POPPLETON HISTORIC STUDY

D-2699

<u>Block</u>	<u>Lot</u>	<u>Address</u>
255	21-7	103-131 Scott Street

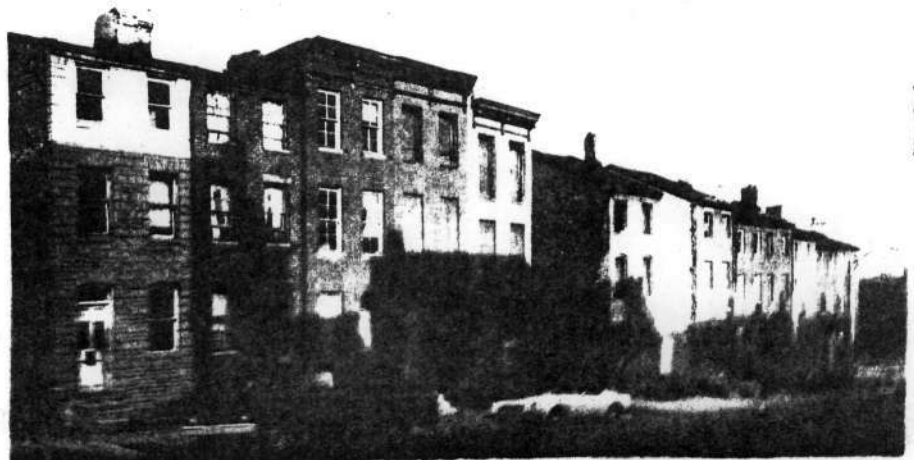
The 1845 tax records show this area as growing, extant houses already taxed. The 3-story gable roofed houses are mid-1840's; number 111 had a nice shop front. Condition is bad, some of the worst in the area, and a great number of vacancies. Should be removed if they cannot be rehabilitated.

Three of 12 houses are occupied, numbers 103, 105 and 127. Lots (15, 7-8) at 115 and 129-131 have been cleared. There is nice variety of form and style in this group and could provide convenient housing for people who work south of Pratt Street. Street treatment, as well as houses, needs major attention.
